## Erosion at Millstream Chichester National Park

April 2011

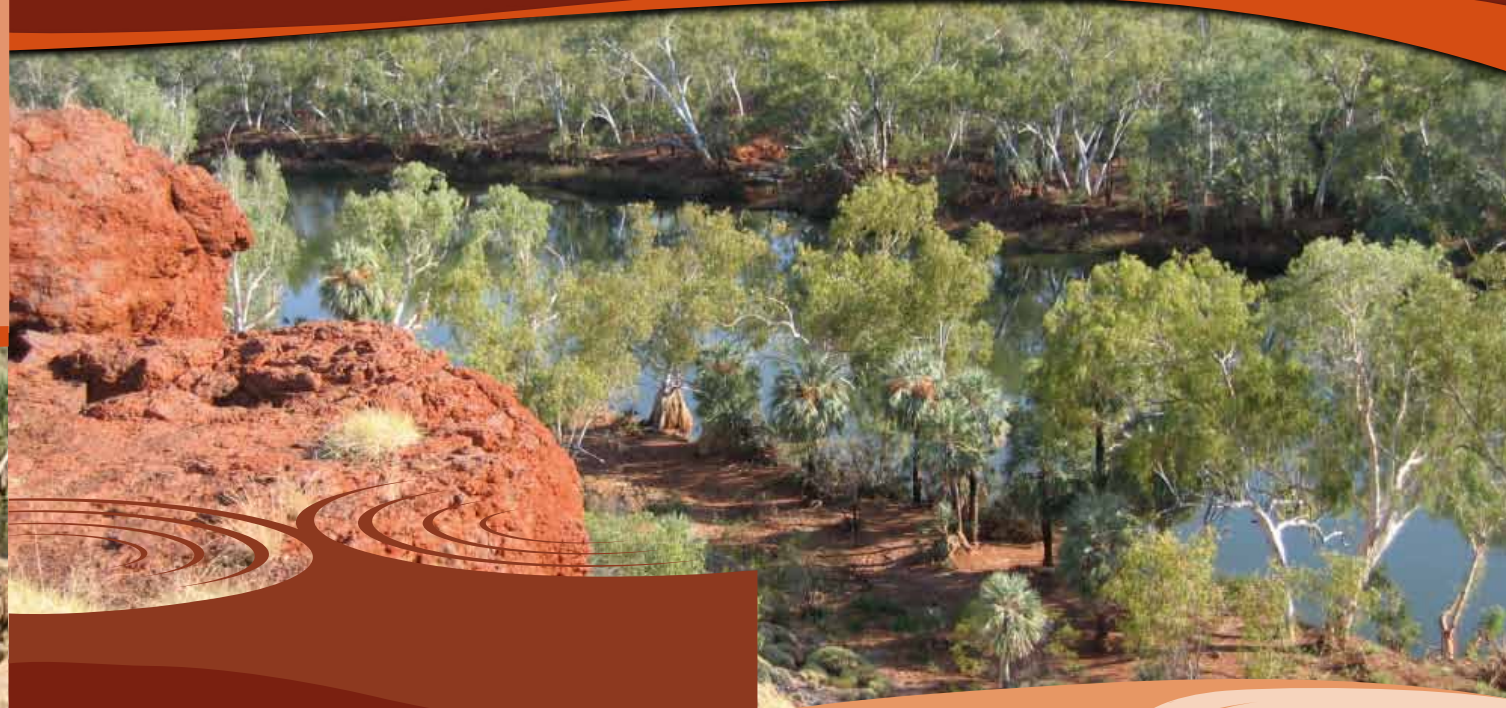
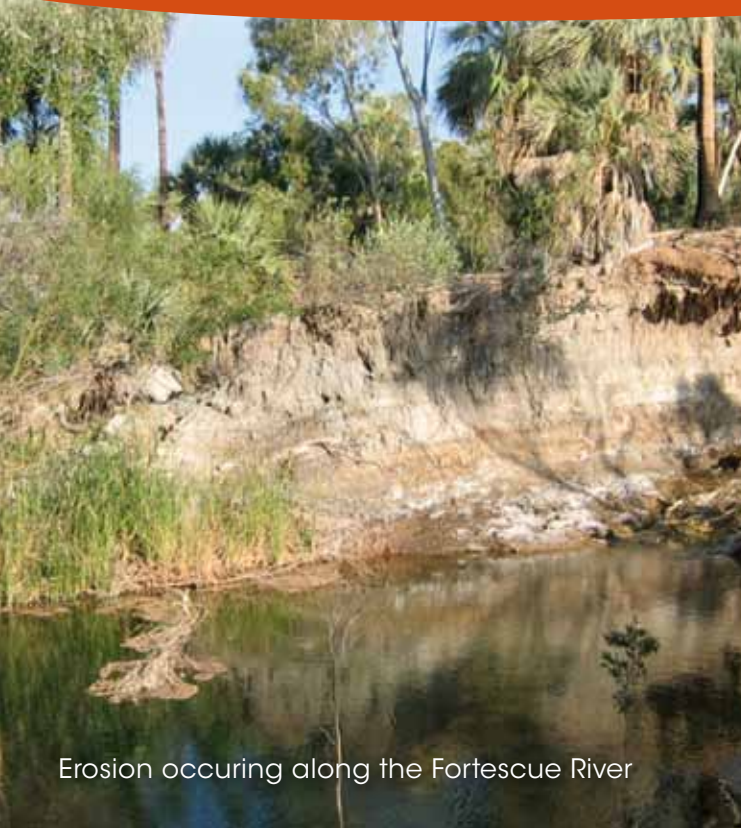
Erosion occurring along the Fortescue River

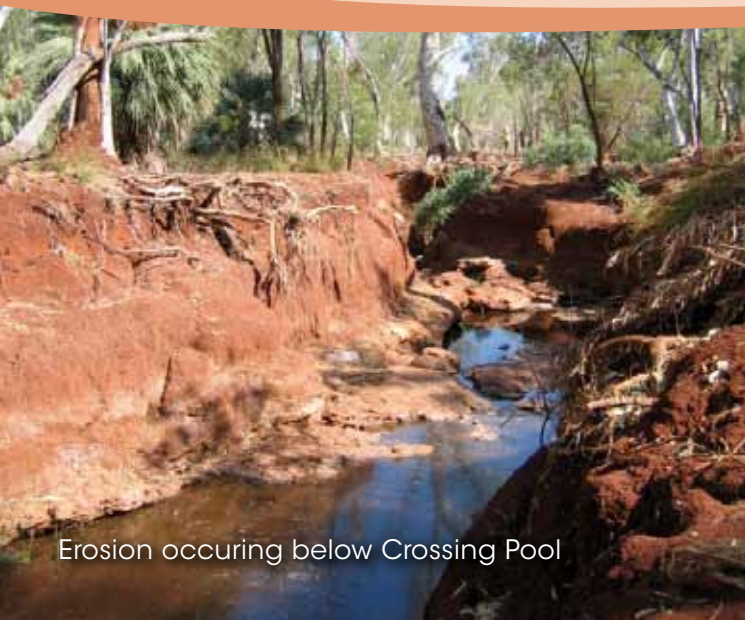
Erosion occurring below Crossing Pool

The major impacts includes loss of riparian vegetation, scouring of river channels and bank erosion at permanent pools. Bank erosion occurred at Crossing Pool in 1988 and more recently in 2009. As a consequence the water level of Crossing Pool is now about 2m lower with obvious impacts to this popular recreation site. Local groundwater levels have also dropped and surrounding vegetation is showing signs of water stress.

Efforts have previously been made to reinstate pool levels at Crossing Pool using sandbags and rubble to slow erosion along channels. These works have only proven effective in the short term and need considerable ongoing effort.

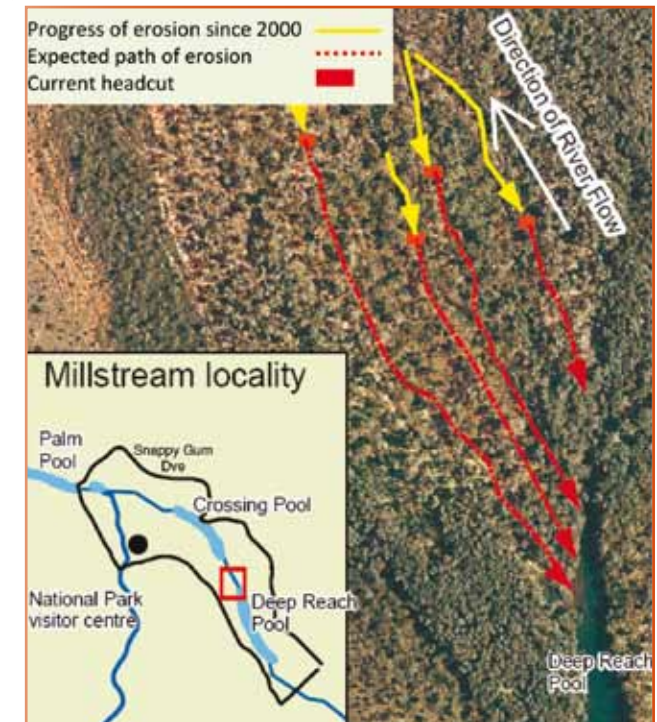
The Department of Water has been monitoring the progress of this erosion since 1979. In 2010 a survey conducted using remote sensing techniques provided a very accurate map of erosion. Erosion was shown to be active downstream of Deep Reach Pool, Palm Pool and Crossing Pool.

Erosion mapping below Deep Reach Pool  
Note: erosion is cutting upstream towards the pools
