Water notes

ADVISORY NOTES FOR LAND MANAGERS ON RIVER AND WETLAND RESTORATION

Importance of Large Woody Debris in sandy bed streams

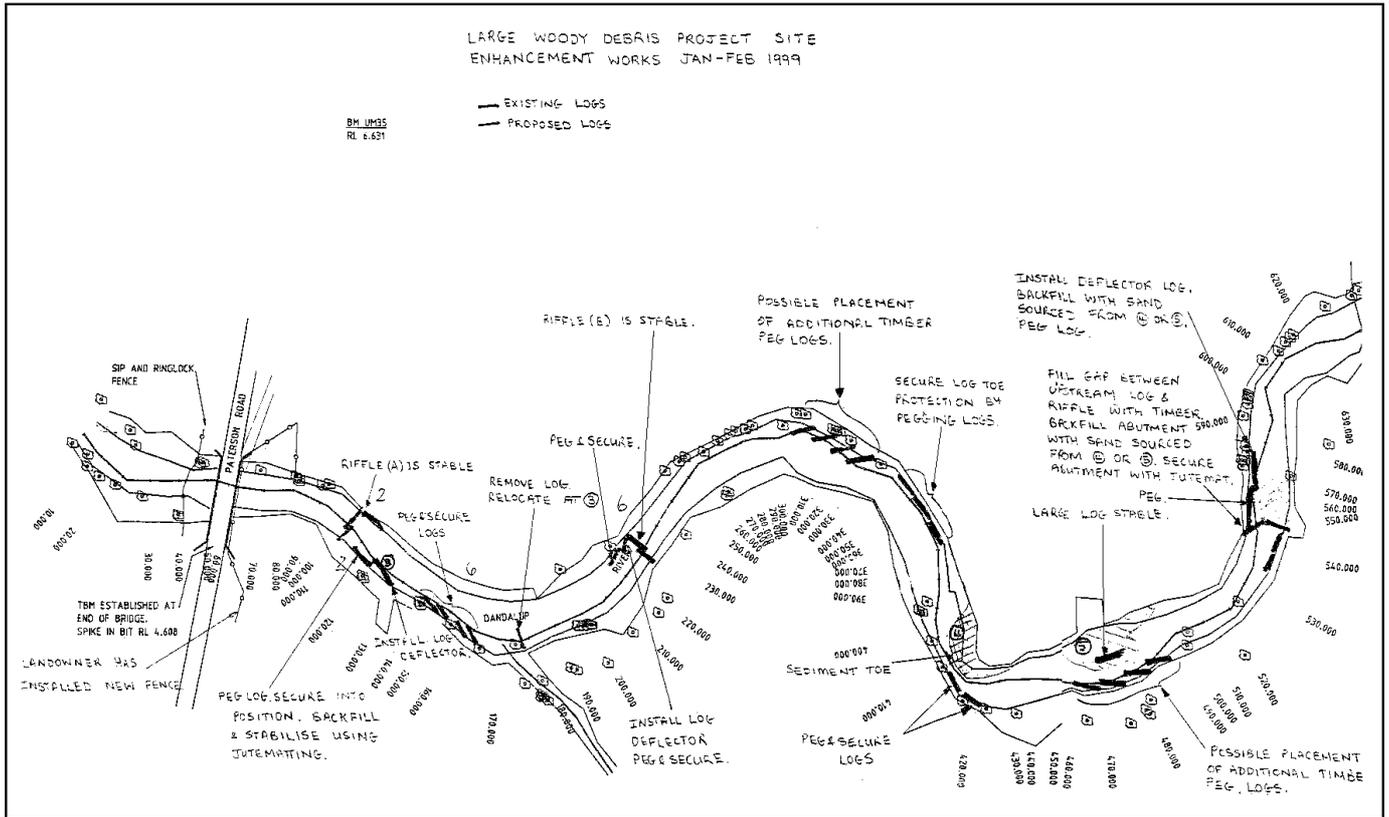
Paterson Road Site Plan.

The Paterson Road site was established in May 1998, with the placement of 40 large tree trunks (some still including the butt) using a hydraulic excavator. At three locations (as shown on the plan) two logs were placed perpendicular to the flow to form "riffles". One very large trunk was placed mid-channel about 470m upstream of the bridge. All other logs were placed as "toe protection" either immediately upstream or downstream of the "riffles" or on the outside of meander bends.

During the 1998 winter, which produced one major bankfull flow, several logs were moved downstream, with two lodged under the Paterson Road Bridge. These logs were moved from the outside of meander bends. The logs in the three perpendicular "riffles" remained in position. Scour holes had developed under and immediately downstream of these "riffles".

In February 1999 the logs which had moved were repositioned, an additional 12 logs were placed in the reach

and 4.5m long pine logs were jetted into the bed to secure the logs placed on the outside of bends.

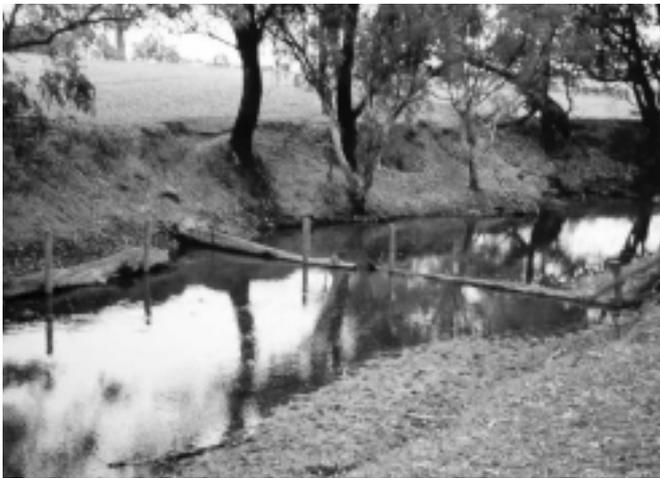
Log riffle B.

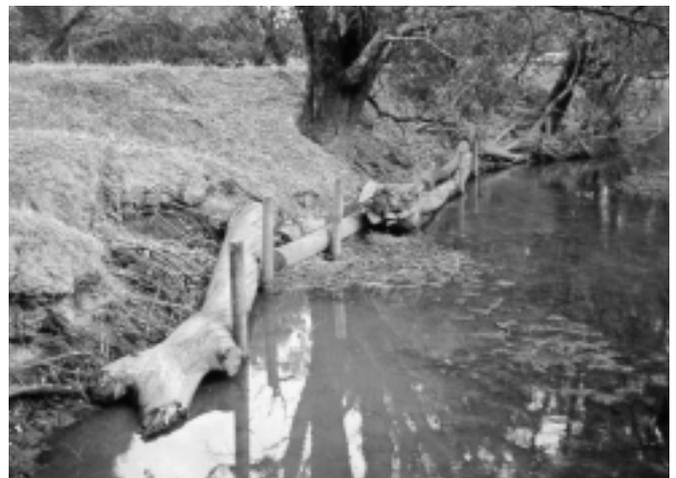
Logs pinned against bank.

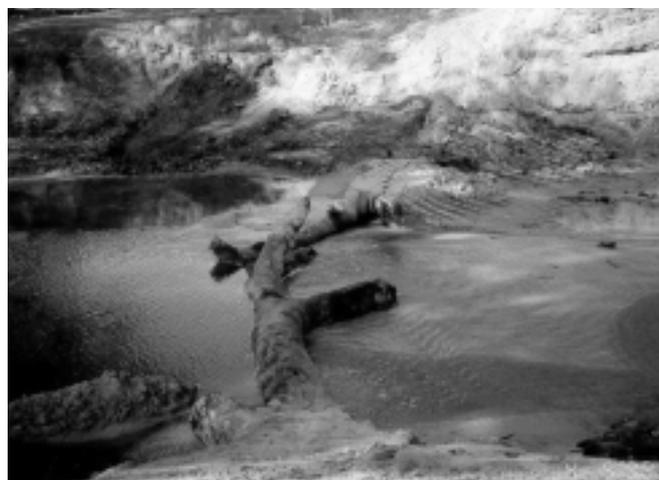
Log riffle C.

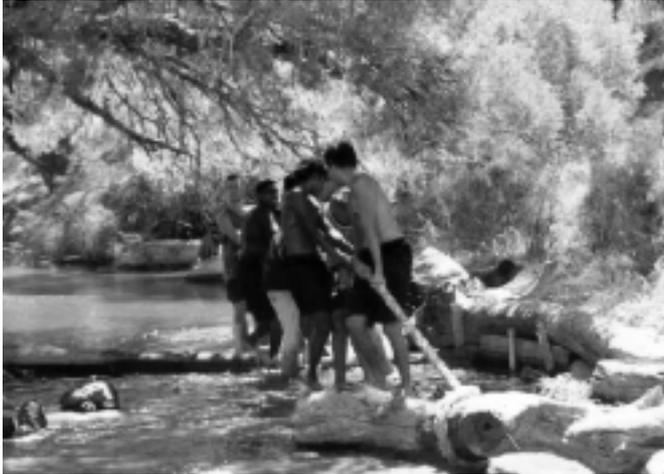
Installing logs at Fairbridge site.

The Fairbridge site was established in March 1999 over a 300 metre reach immediately downstream of a demonstration cattle crossing. As the riparian vegetation is well established in this reach it was not possible to use mechanical equipment to position the logs. Therefore the site was established through the Fairbridge "Ecohouse Project". Ten Landcare trainees manually dragged the logs into position and secured them. Thirty logs of somewhat smaller size than at Paterson Road were positioned. The logs were retained using pine logs and galvanised "fencing droppers" jetted or driven into the bed. Sedges and rushes were also transplanted and brushing installed to protect banks from undercutting. Some minor movement of logs, those partially secured by pine logs, occurred during the 1999 winter. This was easily rectified.

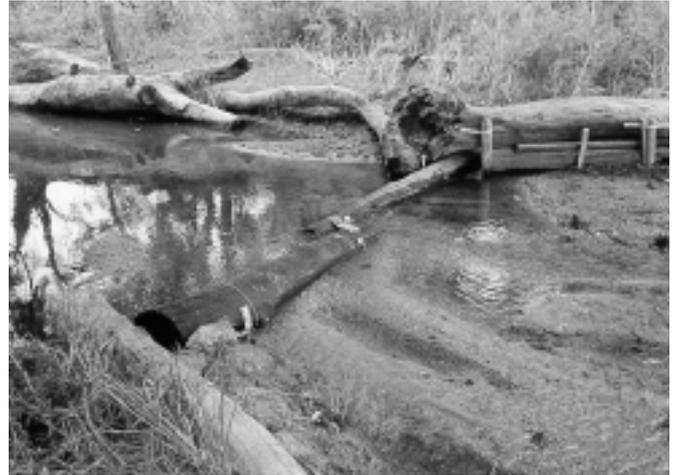
Fairbridge site log riffle.
