# River SCIENCE 14

The science behind the Swan-Canning Cleanup Program

Issue 14, October 2000

## 1998/1999 Canning River Oxygenation Trial

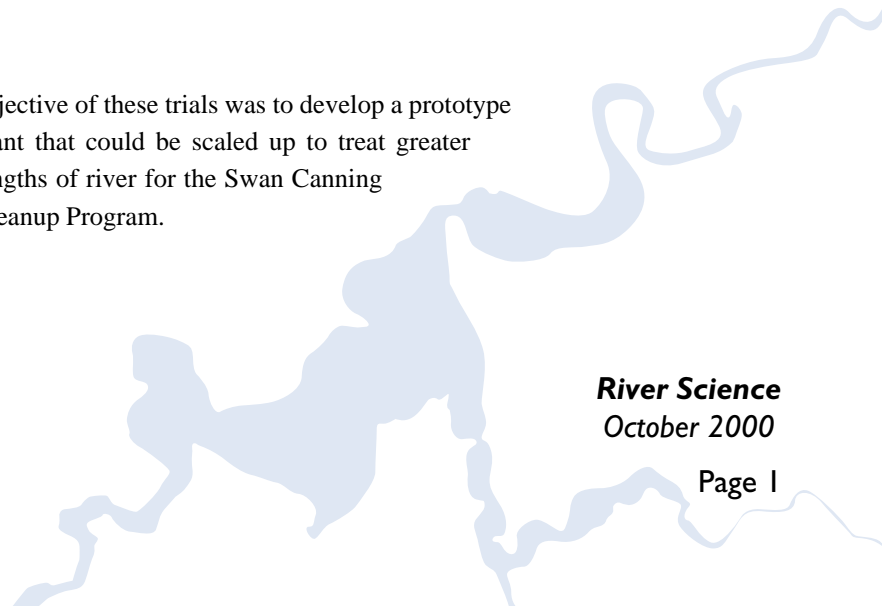
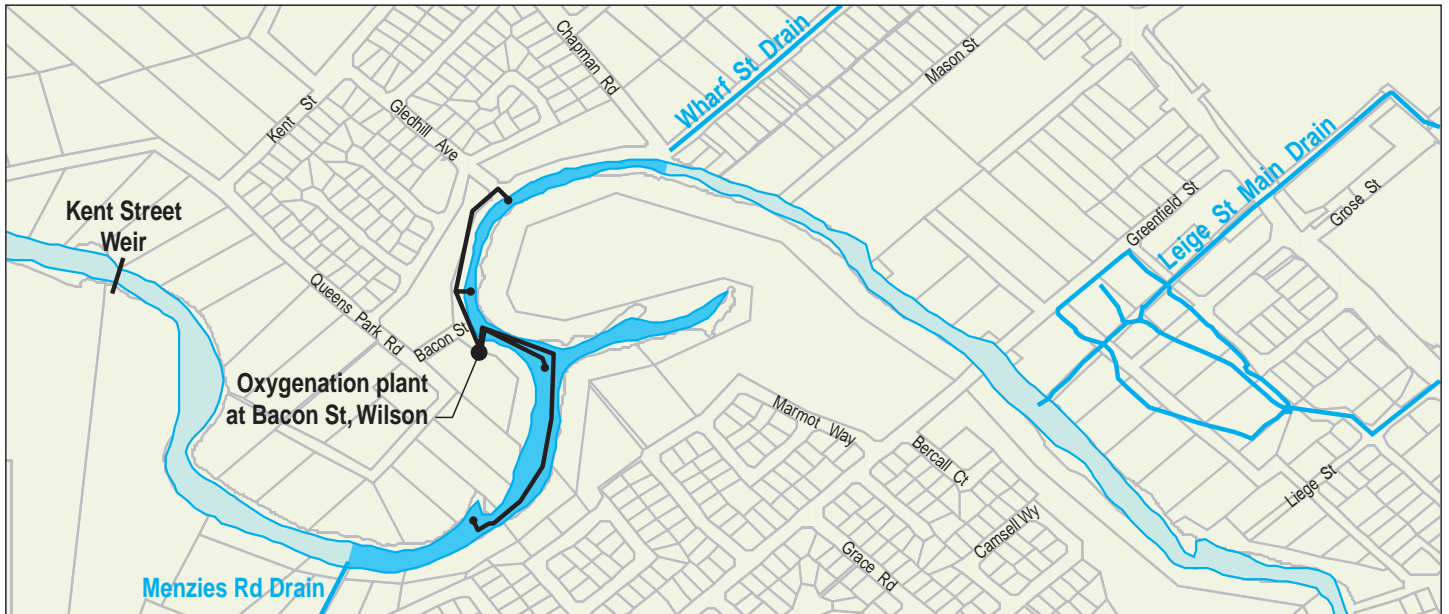
**Figure 2:** Location of oxygenation trial area showing location of plant and layout of diffuser pipes

The treatment area was 1 km long, and stretched 500 m either side of the oxygenation plant, which was situated at Bacon Street in Wilson. This area commonly experiences water quality problems related to anoxia (lack of oxygen) and often experiences severe phytoplankton blooms in summer.

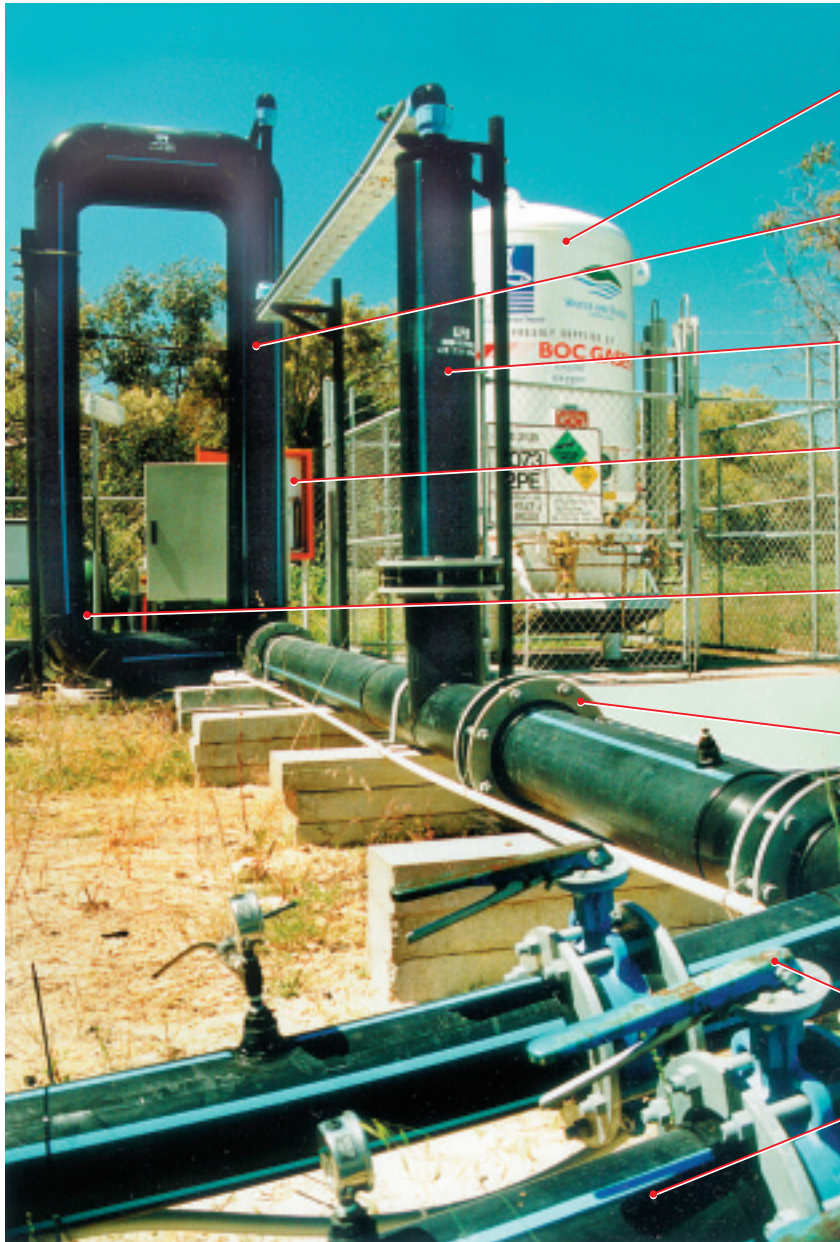
- Liquid oxygen vessel
- U-tube oxygen dissolver
- Pipe returning undissolved oxygen from phase separator to oxygen dissolver
- Control panel
- Pump draws water from the bottom of the river into the oxygen dissolver
- Phase separator collects the undissolved oxygen which is fed back into the dissolver
- Control valves allow flow to be distributed evenly between the pipes
- Distribution pipes return the oxygenated water to the trial area. The oxygenated water is gently diffused back into the river so that it doesn't stir up nutrient rich sediment

**Figure 3:** The oxygenation plant used in the 1998/99 trials

About 85% of the oxygen injected into the river remained in dissolved form. This was a major improvement from the previous trial, when the efficiency of the dissolver used was between 50% and 75%.
